DTC	P0171	System too Lean (Fuel Trim)
------------	--------------	------------------------------------

DTC	P0172	System too Rich (Fuel Trim)
------------	--------------	------------------------------------

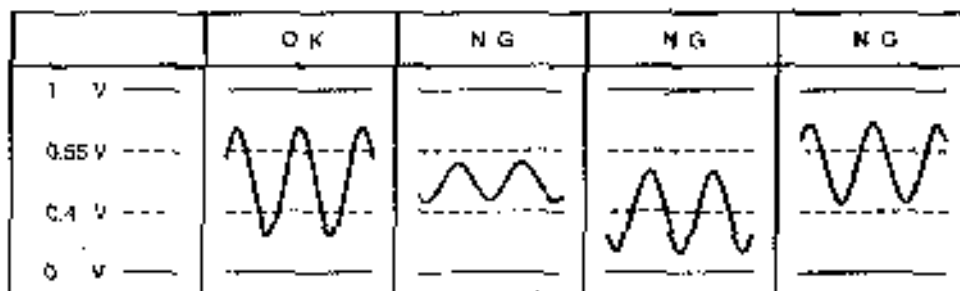
P18349

Oxygen sensor output voltage:

Alternates repeatedly between less than 0.4 V and more than 0.55 V (See the following table).
